# Release Notes for the Cisco CGS 2520 Switch and the CGR 2010 ESM for Cisco IOS Release 12.2(58)EY and Later

**Part Number:** OL-25118-02

These release notes are for Cisco IOS Release 12.2(58)EY and later for the following products:

- Cisco 2520 Connected Grid Switch (Cisco CGS 2520 Switch)
- Cisco Ethernet Switch Module for Cisco 2000 Series Connected Grid Routers (CGR 2010 ESM)

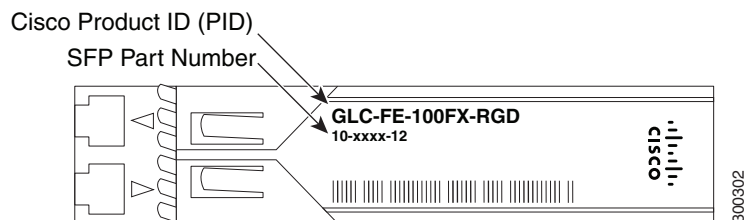
Each SFP has a PID and part number on the label. Verify that the PID on the part label is one of the supported SFPs listed in [Supported Hardware for Far End Fault Indication \(FEFI\), page 5](#). If you are using a GLC-FE-100FX-RGD, also verify that the part number ends in -02 or higher. If the part number for a GLC-FE-100FX-RGD ends in -01, the GLC-FE-100FX-RGD does not support FEFI.

**Figure 1** Cisco Product ID and Part Number Location on Cisco SFP Modules
